**Flood Control Project Maintenance  
Levee Inspections****LMA District Cover Sheet****Spring 2014 Levee Inspection Results****Levee District No. 0009 (Sutter County)**

**Levee Inspection Report By Mile - Spring 2014**

**Levee District No. 0009 (Sutter County)**

Waterway	Bank	Unit Miles	Inspection Start/End	Inspector
Unit No. 01 Sutter County, Feather River	Right	6.24	03/12/2014 03/12/2014	Matthew Hoffman

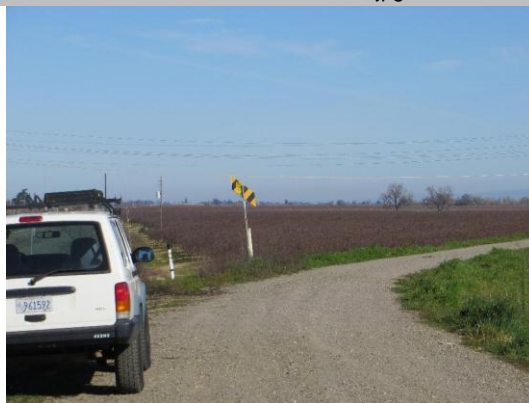
Photo 1 of 1 : UCIP\_181.jpg

LM Start	0.00	Rating **	M	Issue No.	1
LM End	0.00	Issue Type +	En	Location *	LS
Category	Supplemental			GPS Latitude/Longitude	
				Start	End
Item	DWR UCIP Field Study			39.168906 °	39.168906 °
				-121.622629 °	-121.622629 °
DWR ID	DWR_LD0009_01_s _ 2014_1				
Action/Comments					
Inspector Comments: FS_ID:9595					
EP_NO: 3823					
Repair Type:					
Crossing Status:					
UCIP Comments: Need better gas-line markings at levees.					
FIELD_STRUCT_DESC: 8-5/8-inch fuel line along the landward					
shoulder, 2.6 feet below the crown. Gasline marker on LS shoulder					
FS Date: 3/1/2013

Marker on LS shoulder.

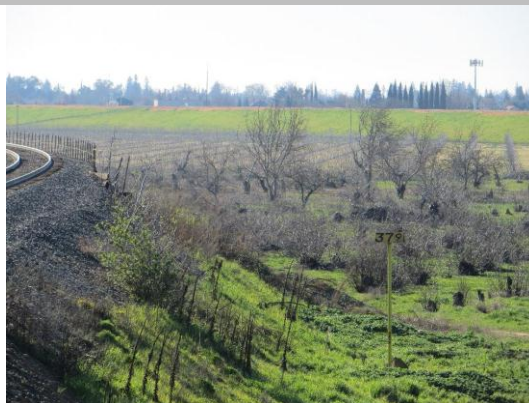
Photo 1 of 1 : UCIP\_180.jpg

LM Start	0.00	Rating **	M	Issue No.	3
LM End	0.00	Issue Type +	En	Location *	LS
Category	Supplemental			GPS Latitude/Longitude	
				Start	End
Item	DWR UCIP Field Study			39.168909 °	39.168909 °
				-121.622629 °	-121.622629 °
DWR ID	DWR_LD0009_01_s _ 2014_3				
Action/Comments					
Inspector Comments: FS_ID:9592					
EP_NO: N/A					
Repair Type:					
Crossing Status:					
UCIP Comments: Need better gas-line markings at levees.					
FIELD_STRUCT_DESC: 8-5/8-inch fuel line through the levee. Sign on					
LS between railroad and end of LD1 puts alignment on west side of RR					
tracks.					
FS Date: 3/1/2013

Sign between railroad and LD 1 puts alignment on west side of railroad tracks.

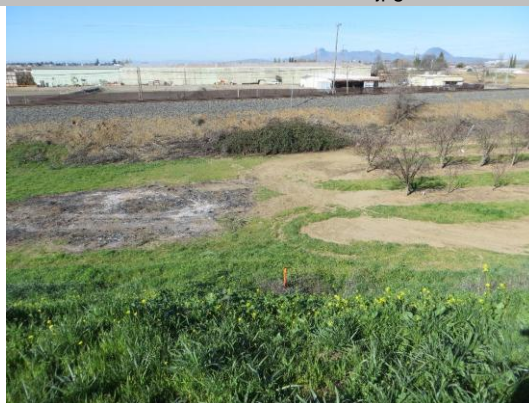
Photo 1 of 1 : UCIP\_183.jpg

LM Start	0.08	Rating **	M	Issue No.	9
LM End	0.08	Issue Type +	En	Location *	WS
Category	Supplemental			GPS Latitude/Longitude	
				Start	End
Item	DWR UCIP Field Study			39.170152 °	39.170152 °
				-121.622546 °	-121.622546 °
DWR ID	DWR_LD0009_01_s _ 2014_9				
Action/Comments					
Inspector Comments: FS_ID:9596					
EP_NO: N/A					
Repair Type:					
Crossing Status:					
UCIP Comments: Need better gas-line markings at levees.					
FIELD_STRUCT_DESC: 16-inch gas line through the levee, 3.5 feet below the crown. Marker on LS toe.					
FS Date: 3/1/2013

Gasline marker at LS toe.

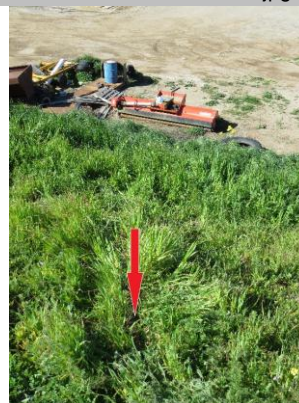
Photo 1 of 1 : UCIP\_185.jpg

LM Start	0.95	Rating **	M	Issue No.	13
LM End	0.95	Issue Type +	En	Location *	LS
Category	Supplemental			GPS Latitude/Longitude	
				Start	End
Item	DWR UCIP Field Study			39.182607 °	39.182607 °
				-121.620774 °	-121.620774 °
DWR ID	DWR_LD0009_01_s _ 2014_13				
Action/Comments					
Inspector Comments: FS_ID:9598					
EP_NO: N/A					
Repair Type:					
Crossing Status:					
UCIP Comments: Pipe needs to be removed from levee crown.					
FIELD_STRUCT_DESC: 3-inch steel pipe through the levee at LS crown elevation.					
FS Date: 3/1/2013

Pipe at crown on LS shoulder.

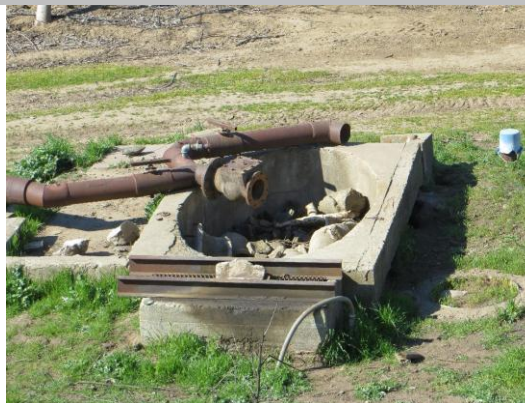
Photo 1 of 1 : UCIP\_187.jpg

LM Start	1.32	Rating **	M	Issue No.	14
LM End	1.32	Issue Type +	En	Location *	LS
Category	Supplemental			GPS Latitude/Longitude	
				Start	End
Item	DWR UCIP Field Study			39.187995 °	39.187995 °
				-121.620706 °	-121.620706 °
DWR ID	DWR_LD0009_01_s _ 2014_14				
Action/Comments					
Inspector Comments: FS_ID:9601					
EP_NO: N/A					
Repair Type:					
Crossing Status:					
UCIP Comments: Unable to determine type of abandonment.					
FIELD_STRUCT_DESC: *Abandoned* 10-inch steel pipe through the					
levee, 2.8 feet below the crown. Waterward end open. Steel plate					
welded on landward end. Pump and standpipe at the landward toe.					
FS Date: 3/1/2013

Abandoned Pump platform on LS toe.

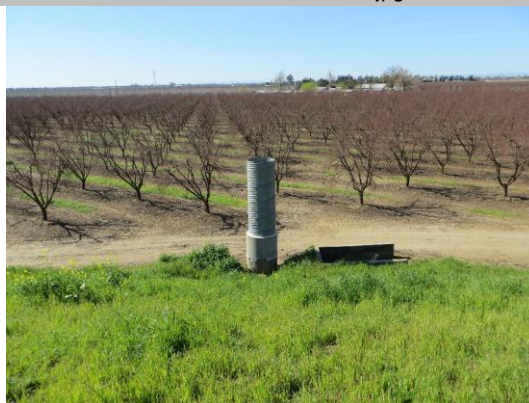
Photo 1 of 1 : UCIP\_189.jpg

LM Start	1.87	Rating **	M	Issue No.	16
LM End	1.87	Issue Type +	En	Location *	LS
Category	Supplemental			GPS Latitude/Longitude	
				Start	End
Item	DWR UCIP Field Study			39.195241 °	39.195241 °
				-121.624165 °	-121.624165 °
DWR ID	DWR_LD0009_01_s _ 2014_16				
Action/Comments					
Inspector Comments: FS_ID:9602					
EP_NO: 1119					
Repair Type:					
Crossing Status:					
UCIP Comments: Pipe needs to be repaired or properly abandoned.					
FIELD_STRUCT_DESC: 16-inch steel pipe through levee, 3.0 feet below crown. Pump in pump house on channel bank. Gate valve on the waterward end. Concrete standpipe and distribution box at the landward toe. (Permit No. 1119, 06/08/1946)					
FS Date: 3/1/2013

Concrete and CMP riser on LS toe.

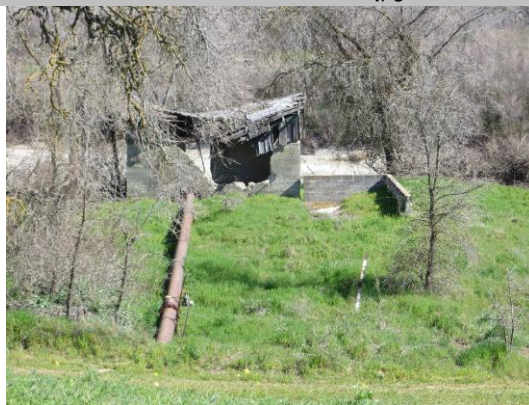
Photo 1 of 1 : UCIP\_194.jpg

LM Start	2.55	Rating **	M	Issue No.	17
LM End	2.55	Issue Type +	En	Location *	LS
Category	Supplemental			GPS Latitude/Longitude	
				Start	End
Item	DWR UCIP Field Study			39.203936 °	39.203936 °
				-121.629521 °	-121.629521 °
DWR ID	DWR_LD0009_01_s _ 2014_17				
Action/Comments					
Inspector Comments: FS_ID:9604					
EP_NO: N/A					
Repair Type:					
Crossing Status:					
UCIP Comments: Pipe appears abandoned as pump is dosconnected and open on waterside. Pipe should be properly abandoned.					
FIELD_STRUCT_DESC: 18-inch steel pipe through levee, 8 feet below crown Pump and gate valve in pump house on channel bank. Concrete well on the bank. Siphon breaker in CMP riser on landward slope. (O+M 1955)					
FS Date: 3/1/2013

Pipe and pumphouse on WS toe/bench.

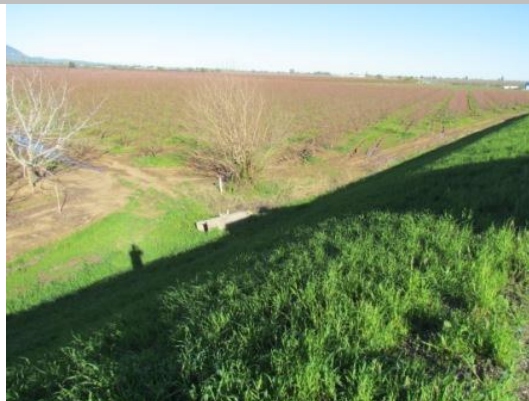
Photo 1 of 1 : mhoffman\_s\_20140313\_265.jpg

LM Start	2.70	Rating **	M	Issue No.	21
LM End	2.70	Issue Type +	Ma	Location *	LS
Category	Earthen Levee			GPS Latitude/Longitude	
				Start	End
Item	Encroachments			39.206053 °	39.206053 °
				-121.629748 °	-121.629748 °
DWR ID	DWR_LD0009_01_f_2013_21				
Action/Comments					
Debris

This photo was taken from the crown facing north looking down the landward levee slope at concrete debris. Spring 2014.

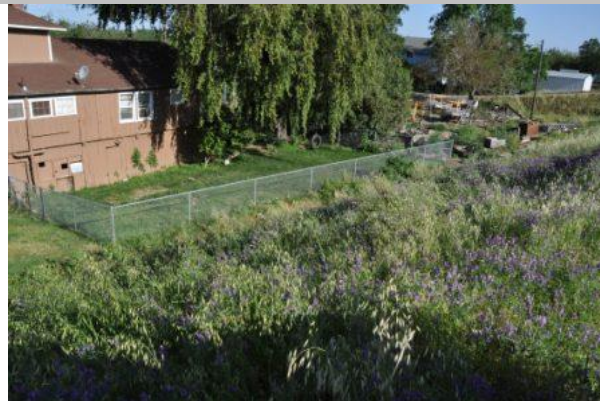
Photo 1 of 1 : mhoffman\_s\_20140306\_013.jpg

LM Start	3.05	Rating **	M	Issue No.	7
LM End	3.06	Issue Type +	En	Location *	LS
Category	Earthen Levee			GPS Latitude/Longitude	
				Start	End
Item	Encroachments			39.211052 °	39.211228 °
				-121.628851 °	-121.628808 °
DWR ID	DWR_LD0009_01_s_2012_7				
Action/Comments					
Fence

L/S fence along levee toe.

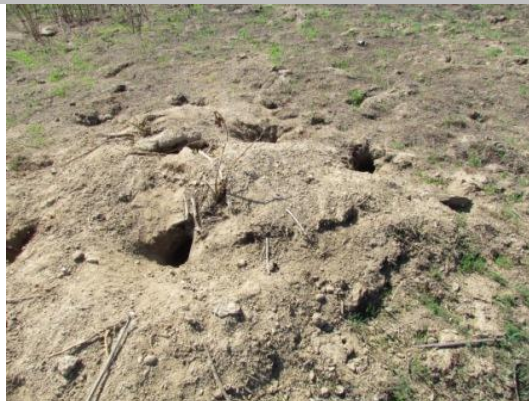
Photo 1 of 1 : mhoffman\_s\_20140306\_019.jpg

LM Start	3.10	Rating **	U	Issue No.	22		
LM End	3.30	Issue Type +	Ma	Location *	WS		
Category	Earthen Levee			GPS Latitude/Longitude			
				Start	End		
Item	Animal Control				°		°
					°		°
DWR ID	DWR_LD0009_01_f_2013_22						
Action/Comments							
No rodents visible, but rodent burrows visible; need to backfill and compact or grout burrows. Inspector Comments: Large burrows on waterward levee slope. Will be repaired when the slurry wall is installed summer 2014.

Photo taken looking south from the toe of the levee at rodent holes on the waterward slope.

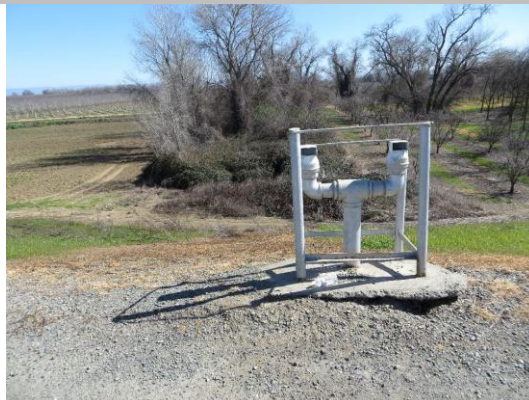
Photo 1 of 1 : UCIP\_198.jpg

LM Start	3.49	Rating **	M	Issue No.	18
LM End	3.49	Issue Type +	En	Location *	WS
Category	Supplemental			GPS Latitude/Longitude	
				Start	End
Item	DWR UCIP Field Study			39.217362 °	39.217362 °
				-121.628433 °	-121.628433 °
DWR ID	DWR_LD0009_01_s_2014_18				
Action/Comments					
Inspector Comments: FS_ID:9606					
EP_NO: 13657					
Repair Type:					
Crossing Status:					
UCIP Comments: Needs flapgate on WS outlet. Pump is missing.					
FIELD_STRUCT_DESC: 20-inch pipe through levee, 2 feet below levee crown. Siphon breaker on waterward shoulder. Pump with trash rack at landward toe. (Permit No. 13657 - Micheli)					
FS Date: 3/1/2013

Siphon Breakers on WS shoulder.

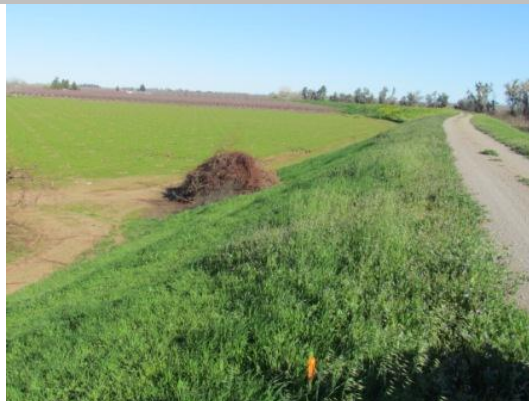
Photo 1 of 1 : mhoffman\_s\_20140313\_266.jpg

LM Start	4.27	Rating **	M	Issue No.	23
LM End	4.27	Issue Type +	En	Location *	LS
Category	Earthen Levee			GPS Latitude/Longitude	
				Start	End
Item	Encroachments			39.228589 °	39.228589 °
				-121.629732 °	-121.629732 °
DWR ID	DWR_LD0009_01_f_2013_23				
Action/Comments					
Prunings

This photo was taken from the crown facing north looking down the landward levee slope at a pruning pile on at the toe. Spring 2014.

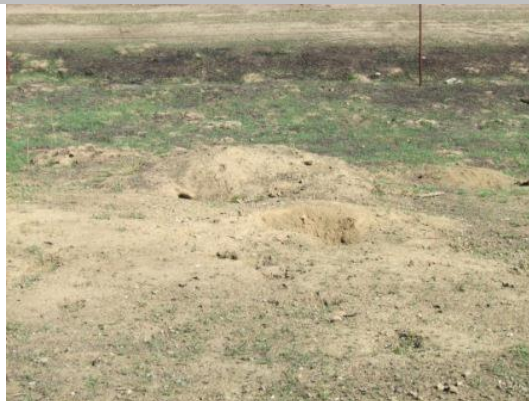
Photo 1 of 1 : mhoffman\_s\_20140306\_014.jpg

LM Start	4.69	Rating **	U	Issue No.	10
LM End	4.69	Issue Type +	Ma	Location *	WS
Category	Earthen Levee			GPS Latitude/Longitude	
				Start	End
Item	Animal Control			39.234343 °	39.234343 °
				-121.632200 °	-121.632200 °
DWR ID	DWR_LD0009_01_f_2013_10				
Action/Comments					
No rodents visible, but rodent burrows visible; need to backfill and compact or grout burrows.

Photo taken from the levee crown looking east down the waterward slope at rodent holes.

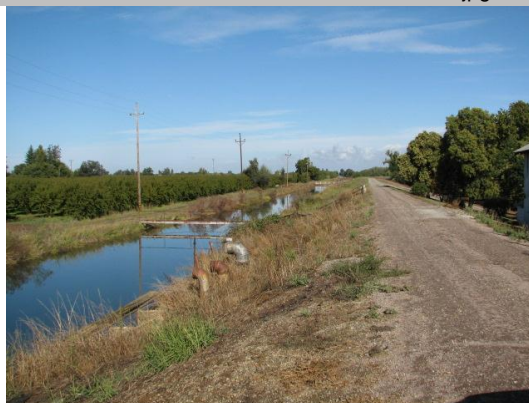
Photo 1 of 1 : mhoffman\_s\_20140306\_016.jpg

LM Start	5.68	Rating **	M	Issue No.	12
LM End	6.02	Issue Type +	En	Location *	LS
Category	Earthen Levee			GPS Latitude/Longitude	
				Start	End
Item	Encroachments			39.247695 °	39.252631 °
				-121.637316 °	-121.636970 °
DWR ID	DWR_LD0009_01_s_2012_12				
Action/Comments					
Ditch

Agricultural ditch at landside toe.

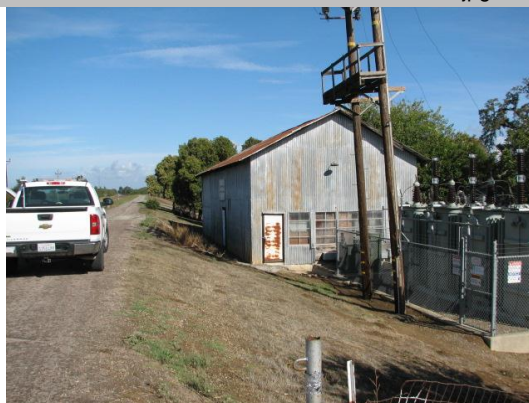
Photo 1 of 1 : mhoffman\_s\_20140306\_015.jpg

LM Start	5.68	Rating **	U	Issue No.	11
LM End	5.68	Issue Type +	En	Location *	WS
Category	Earthen Levee			GPS Latitude/Longitude	
				Start	End
Item	Encroachments			39.247697 °	39.247697 °
				-121.637312 °	-121.637312 °
DWR ID	DWR_LD0009_01_s_2012_11				
Action/Comments					
Building

Building at the waterside toe.

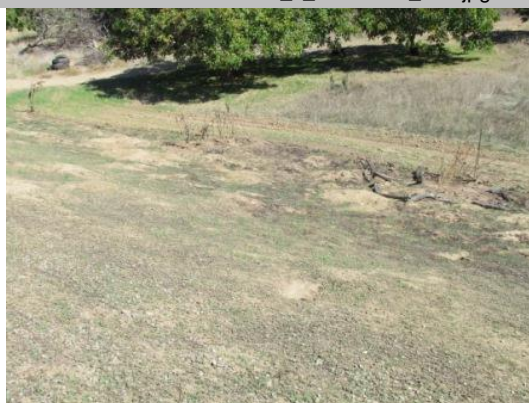
Photo 1 of 1 : mhoffman\_s\_20140306\_020.jpg

LM Start	5.76	Rating **	U	Issue No.	24
LM End	5.76	Issue Type +	Ma	Location *	WS
Category	Earthen Levee			GPS Latitude/Longitude	
				Start	End
Item	Animal Control			39.248868 °	39.248868 °
				-121.637232 °	-121.637232 °
DWR ID	DWR_LD0009_01_f_2013_24				
Action/Comments					
No rodents visible, but rodent burrows visible; need to backfill and compact or grout burrows.

Photo taken from levee crown looking down waterward slope at rodent holes.

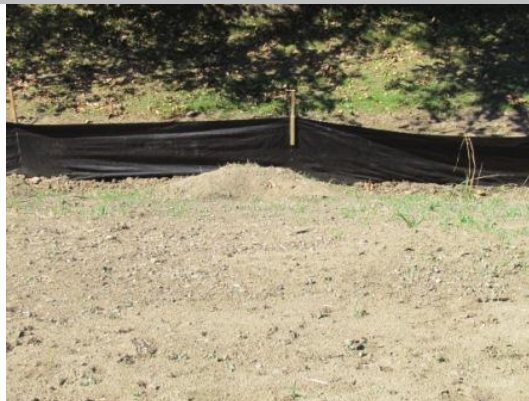
Photo 1 of 1 : mhoffman\_s\_20140306\_021.jpg

LM Start	6.14	Rating **	U	Issue No.	25
LM End	6.14	Issue Type +	Ma	Location *	LS
Category	Earthen Levee			GPS Latitude/Longitude	
				Start	End
Item	Animal Control			39.254369 °	39.254369 °
				-121.636531 °	-121.636531 °
DWR ID	DWR_LD0009_01_f_2013_25				
Action/Comments					
No rodents visible, but rodent burrows visible; need to backfill and compact or aROUT burrows.

Photo taken from levee crown looking west down landward slope at rodent holes.
